**Synthetic lining - long-term corrosion protection for concrete manholes**

# MANHOLE REHABILITATION

# Manhole rehabilitation procedures by PREDL GmbH

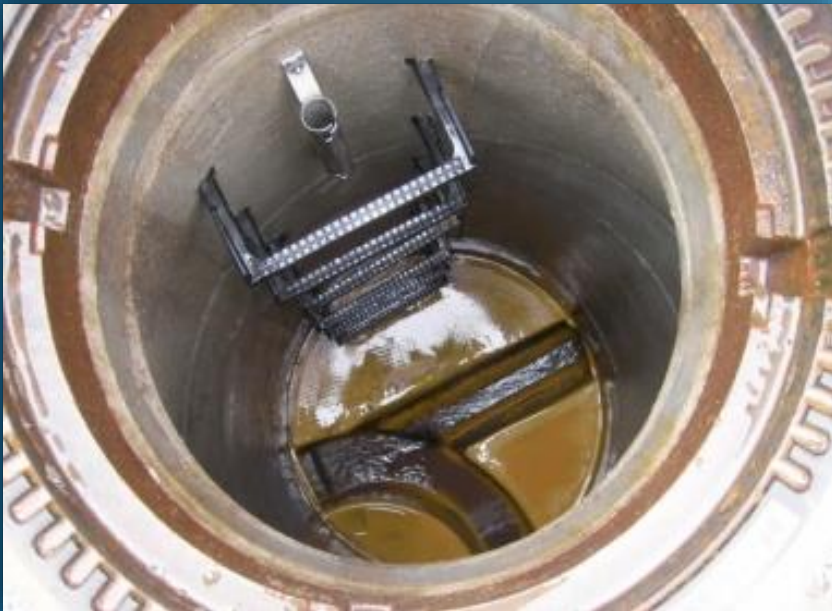
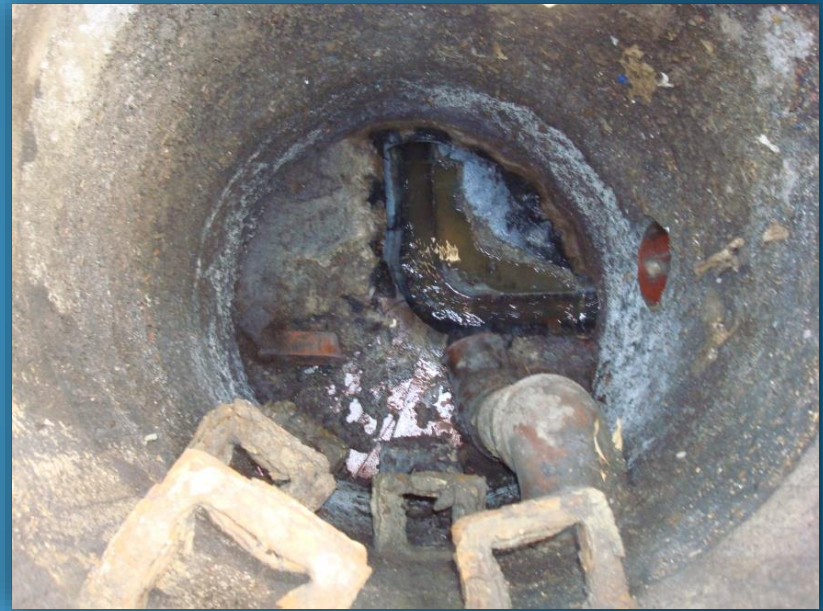
# Sewer manhole with and without corrosion protection in the channel after 15 years

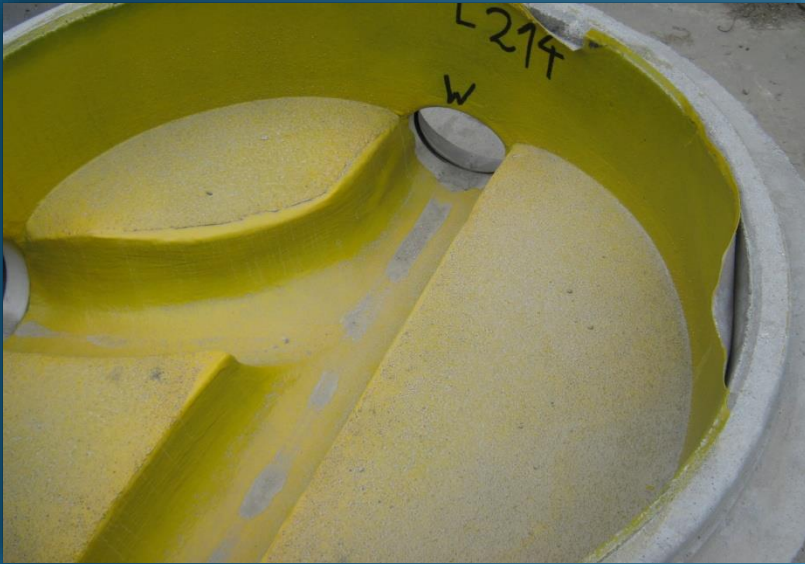
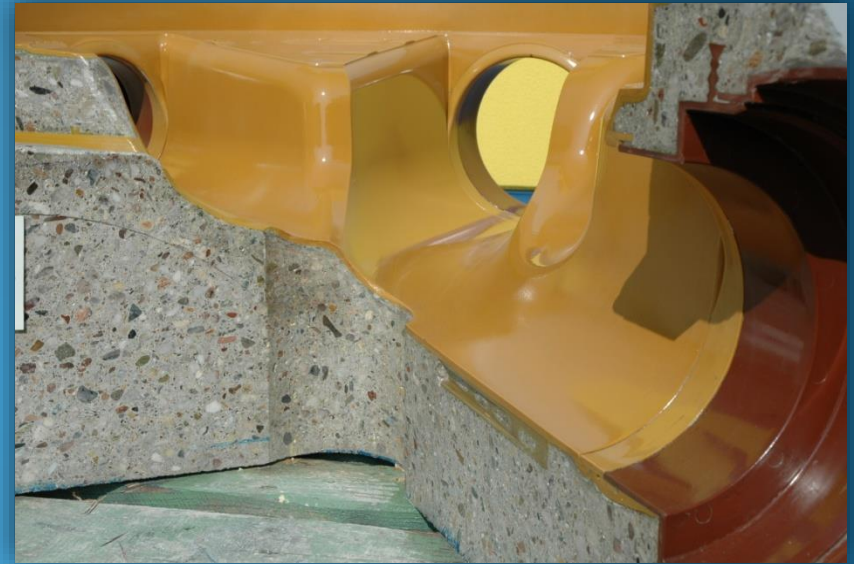
# Coating – equivalent to the PREDL base-liner ?

## Disadvantages of the coating :

- Extensive preparation (clearing work, drying....)
- The manhole does not gain any structural strength
- Often insufficient strength of the bounding laminate

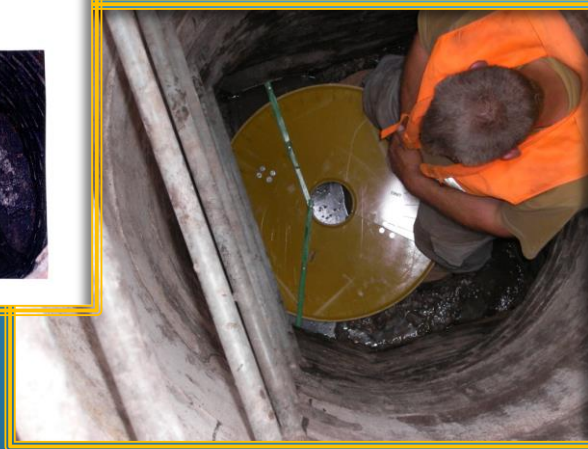
## Manual measurement

High error rate as manholes are often not walkable or only with great difficulty

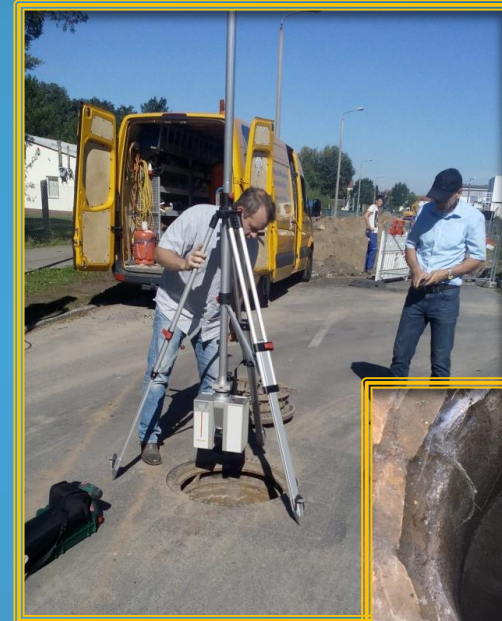
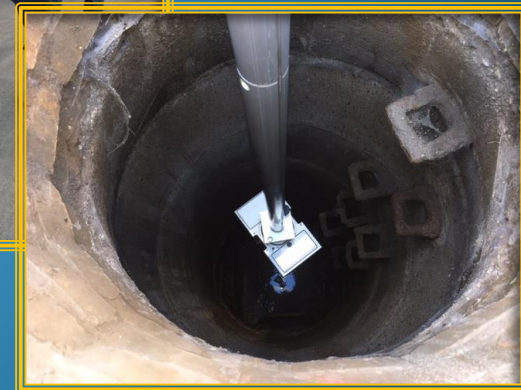
## Laser scan

The most modern technology for a precise modelling

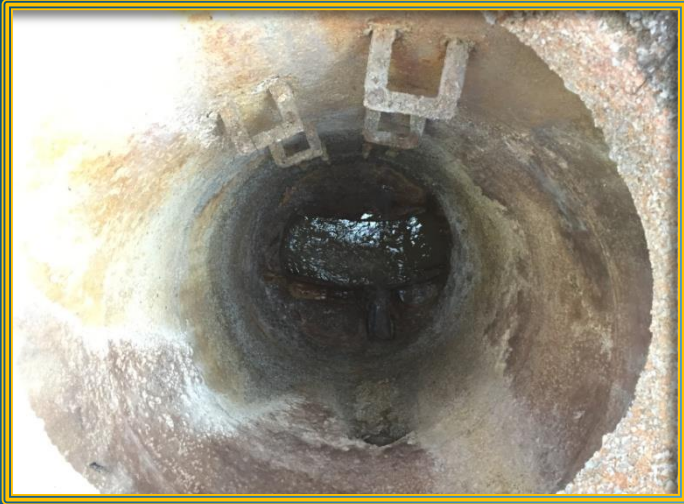
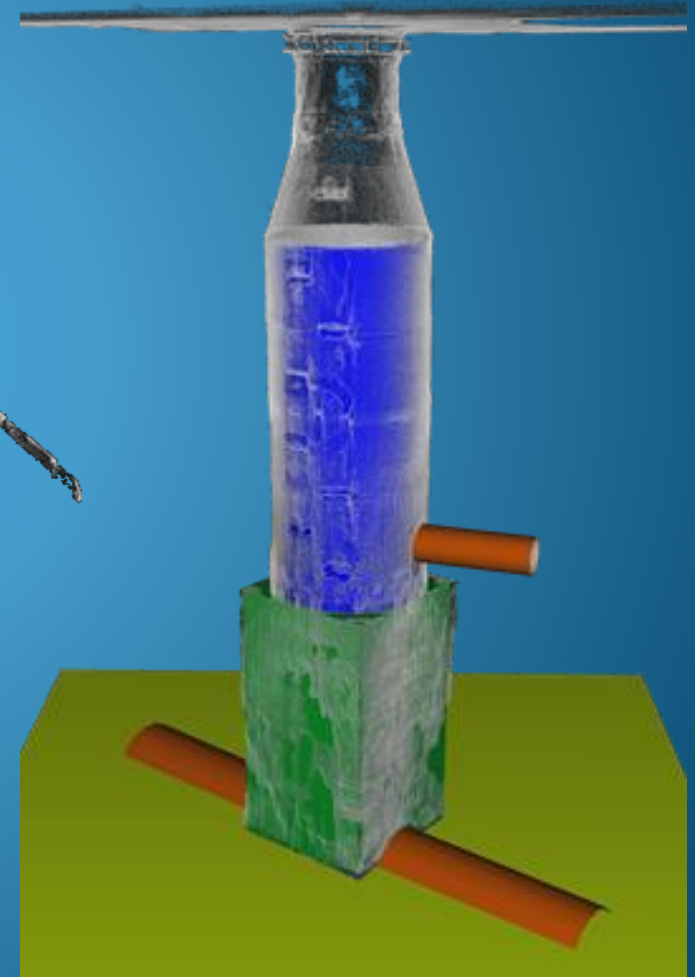
# Laser scan – 3D modelling of the old manhole

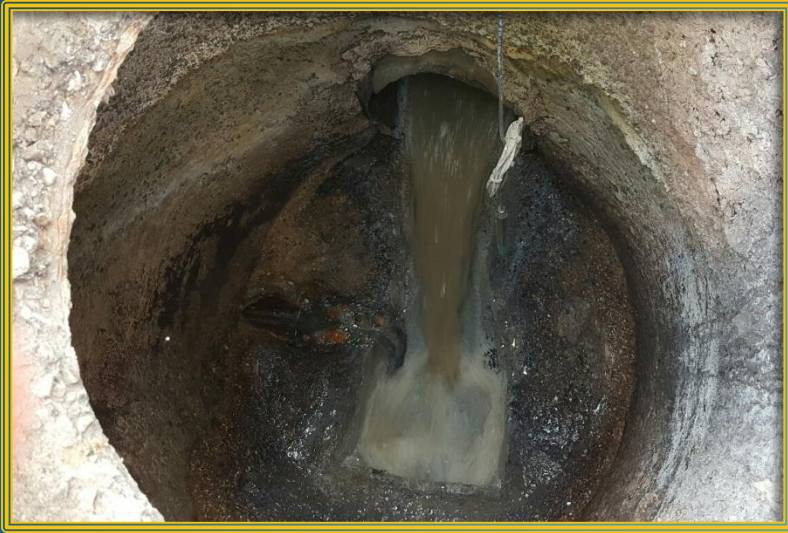
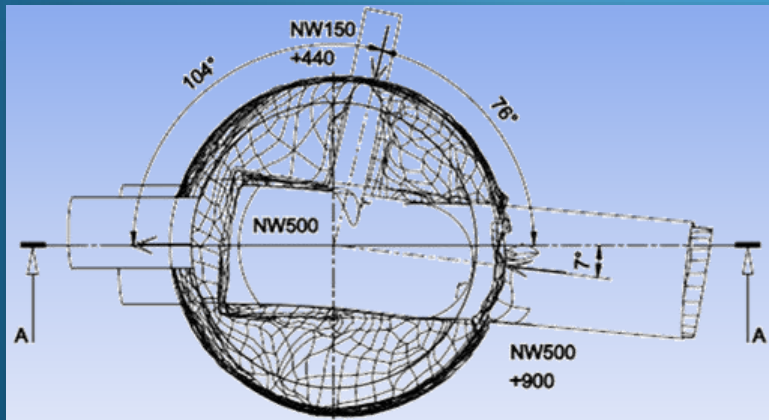
# Laser scan – 3D modelling of the old manhole

Laser scan – Modelling of a manhole that needs rehabilitating in Jersey

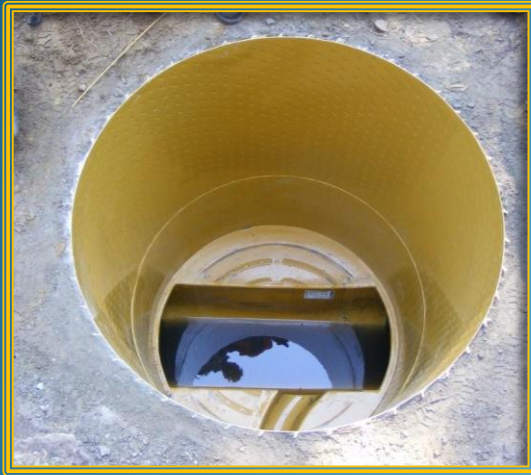
Rehabilitation with CORPROTECT PP lining  
(coverslab off or through entry hole)

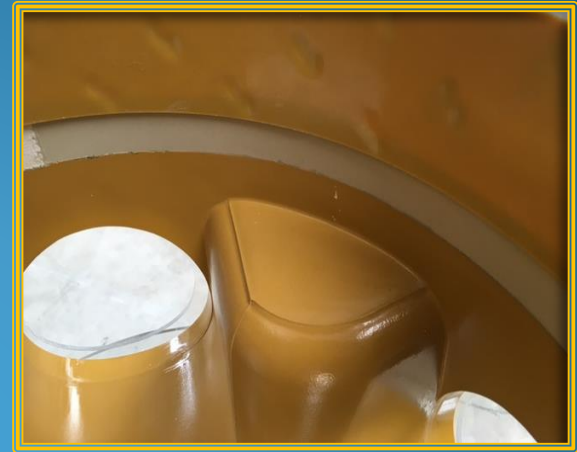
Rehabilitation with GRP base-liner +  
CORPROTECT liner

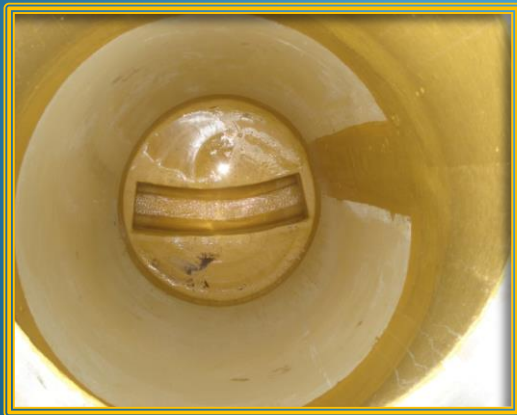
Rehabilitation with GRP base-liner +  
GRP shaft lining 3 mm

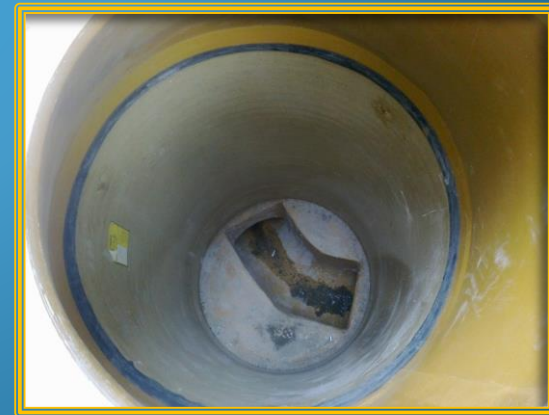
Manhole in manhole solution with GRP  
manhole base + GRP pipe

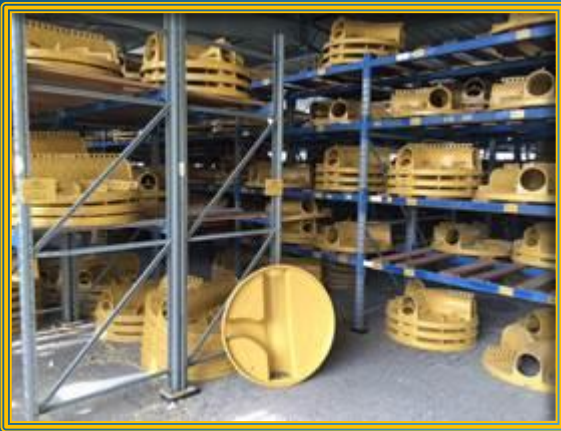
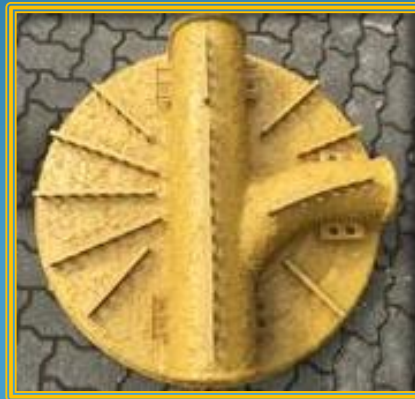
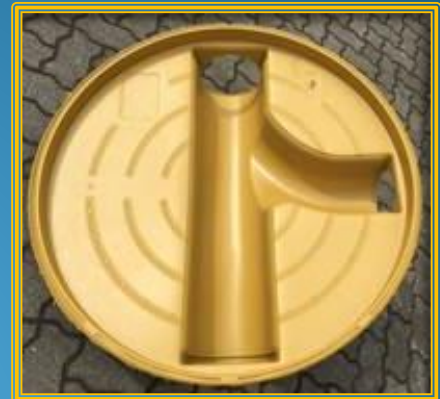
Large choice of base-liners from the wide PP standard programme range

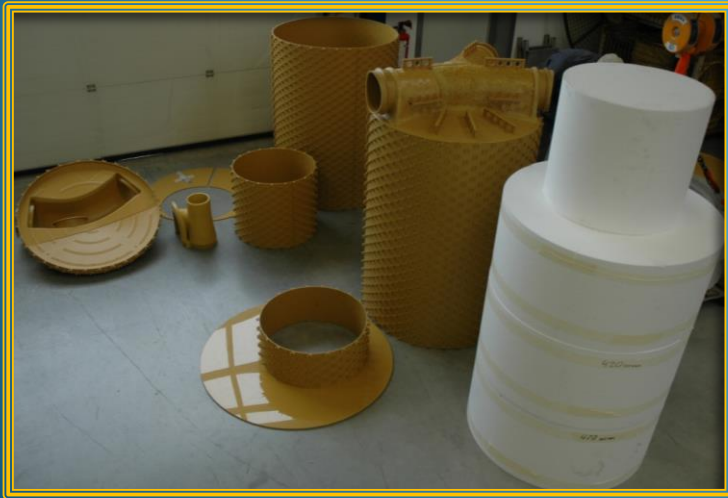
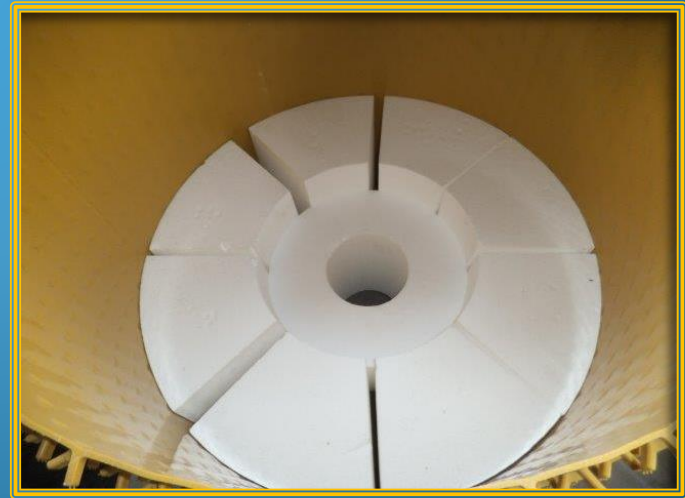
Rehabilitation components : PP base-liners, CORPROTECT PP liner also for coverslab, EPS shuttering

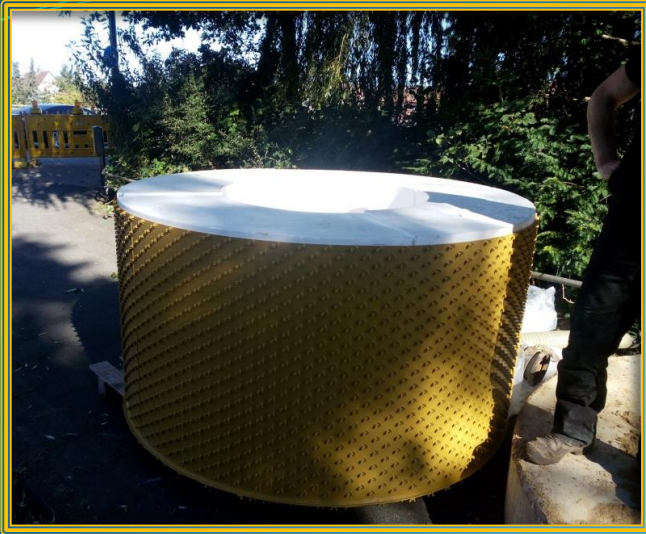
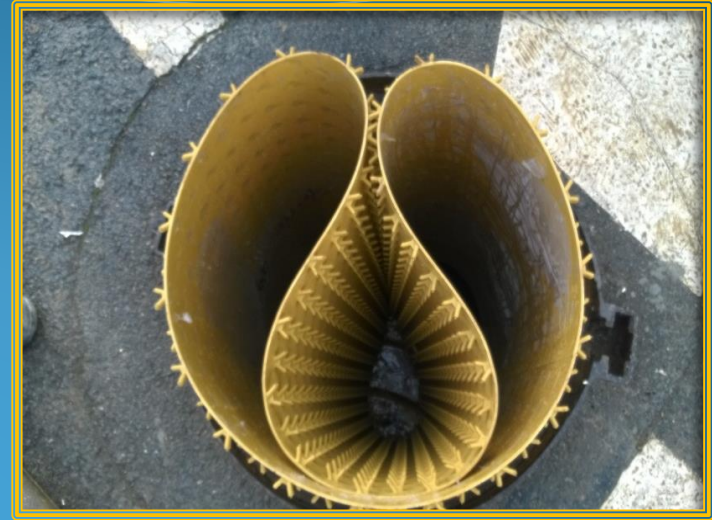
Rehabilitation with CORPROTECT  
In an open field or through the entry hole

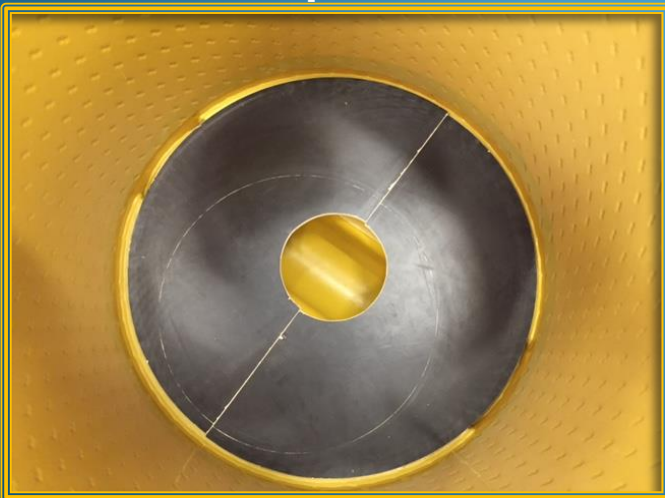
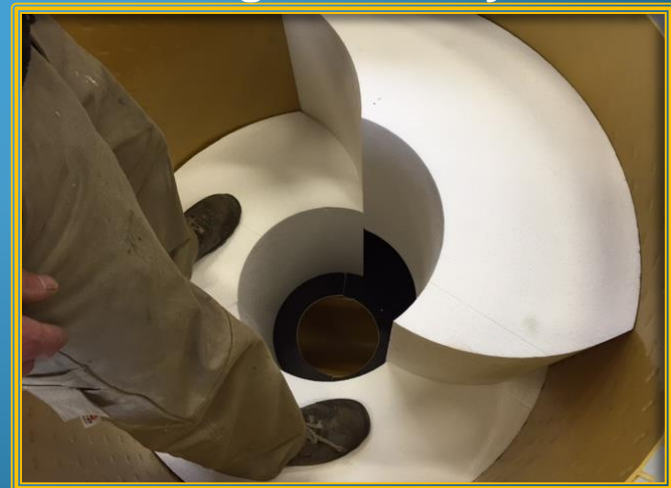
Abstützung der CORPROTECT-Auskleidung mit EPS

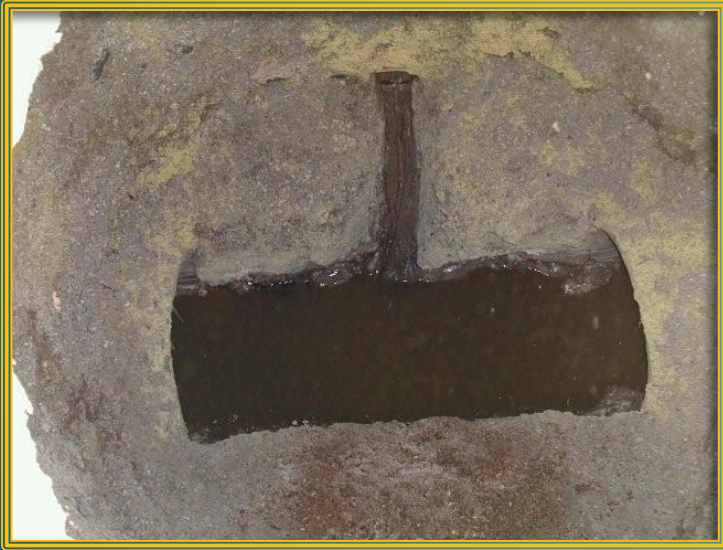
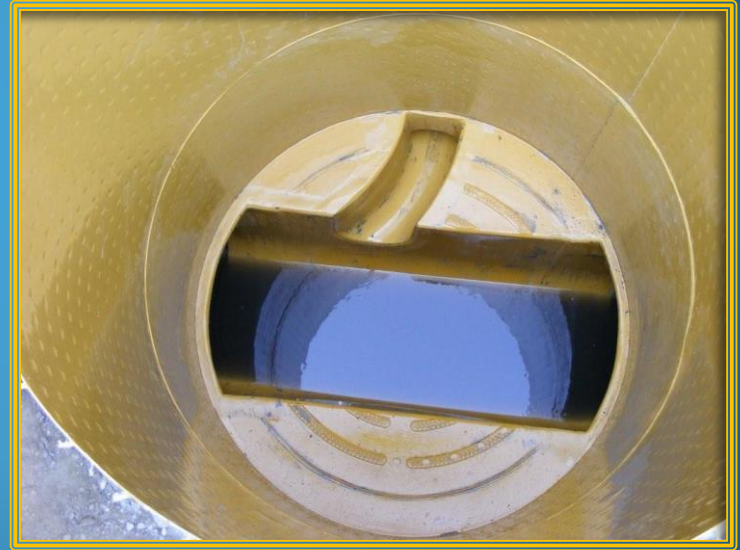
Before

afterwards
